# Corrosion Control in Drinking Water Distribution Using Simple Methods

## Part 6: Experiments to Determine the Corrosion Rate and Copper Release

Norbert Konradt, Monika Konradt, Detlef Schroden and Peter Janknecht, Trinkwasser Consulting, 45355 Essen, Germany

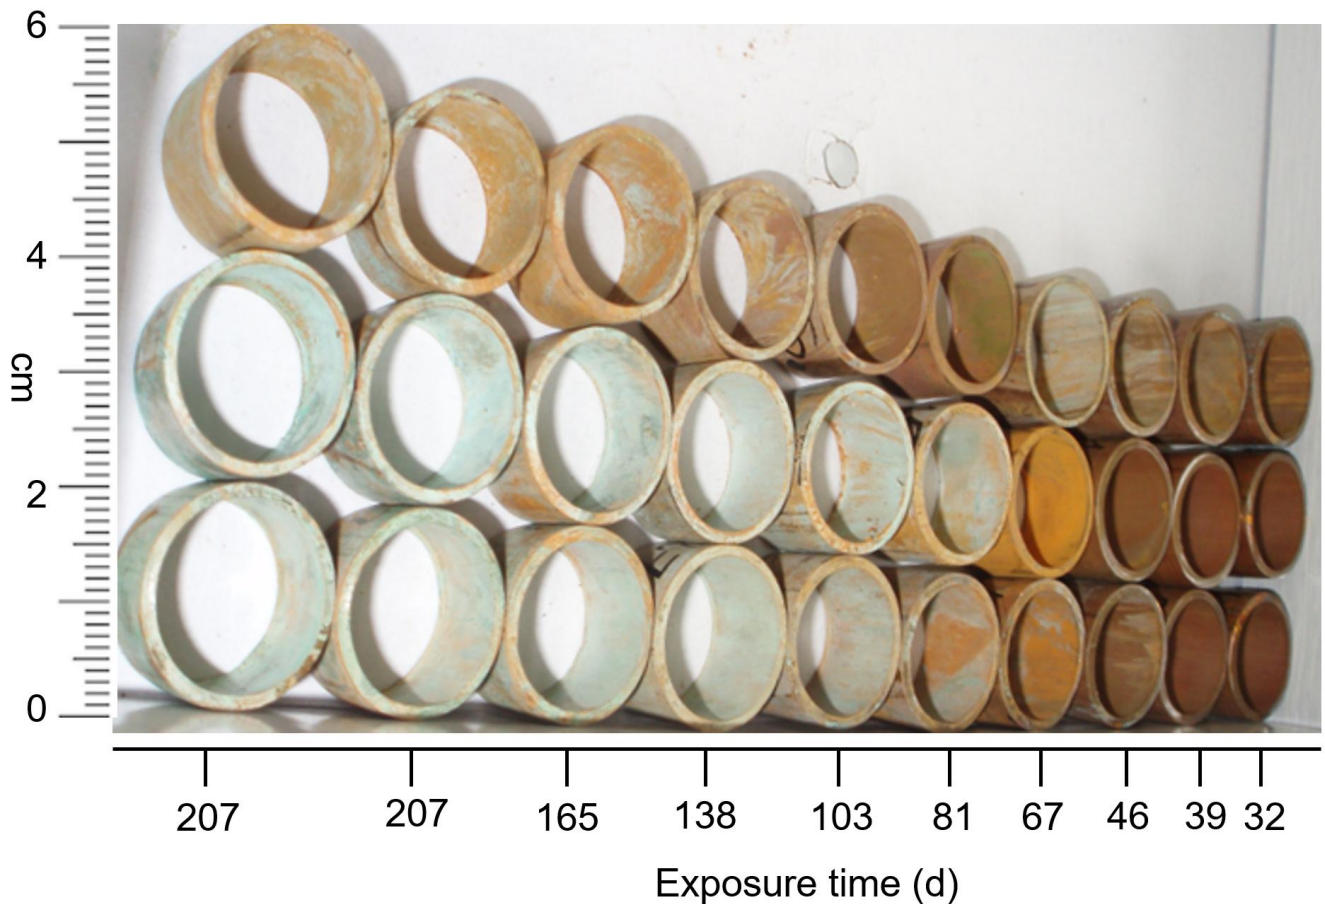
**Figure 2.** Corroded copper segments after exposure in Water 1, 2 and 3 (from bottom to top).

After 32 days, the segments, which were bare at the start, were visually covered with a reddish-brown layer, which presumably consisted of copper(I) oxide (Figure 2). From the 81<sup>st</sup> day onwards, light blue deposits, originating from copper(II) compounds, dominated in Water 1 and Water 2. From the 138<sup>th</sup> day onwards, the segments from softened Water 3 showed an uneven surface with streaky deposits in the direction of flow. Weight determination after the exposure phase revealed a weight loss for each segment. This demonstrates that the release of copper into the water was a significant process. To determine the corrosion rate, the scale must be removed, as it may contain not only the corroded copper but also reactants such as oxygen and carbon, as well as minerals precipitated from the water—such as calcite or humic substances.

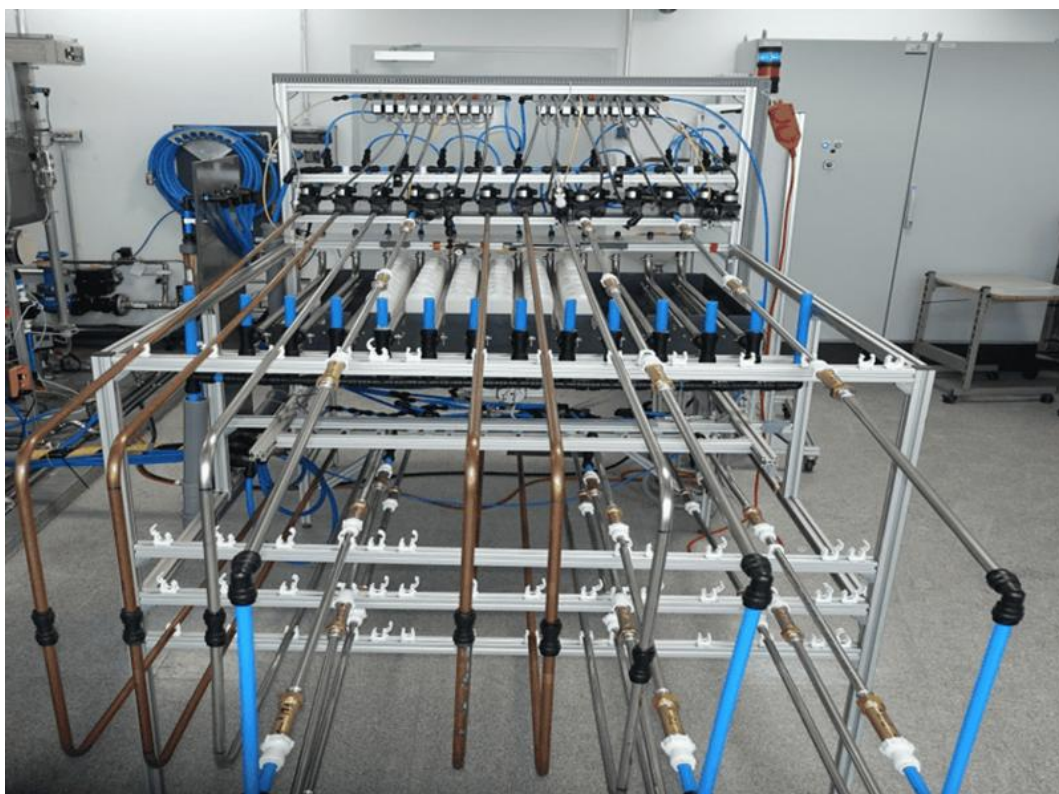
**Figure 6.** Corrosion test rig in accordance with EN 15664-1 from TZW, Karlsruhe.

The tests were conducted using a rig test in accordance with EN 15664-1 from the DVGW Technology Center Water in Karlsruhe. For each water, the installation was set up with two parallel test pipes made of copper and one control pipe made of stainless steel. A corresponding corrosion test rig is shown in [Figure 6](#).

The copper pipes, conforming to EN 1057 [5]—which had a length of 5 m, an inner diameter of 13 mm, an inner surface area of 0.204 m<sup>2</sup>, and a volume of 0.663 L—were used in the test rig.
